APPENDIX H

**SUPPORTING INFORMATION
FOR CULTURAL RESOURCES**

**Case Study/Adaptive Reuse Alternatives Report for
Camp Pinchot Historic District
Eglin Air Force Base
Okaloosa County, Florida**

FINAL
Case Study/Adaptive Reuse Alternatives Report for
Camp Pinchot Historic District
Eglin Air Force Base
Okaloosa County, Florida

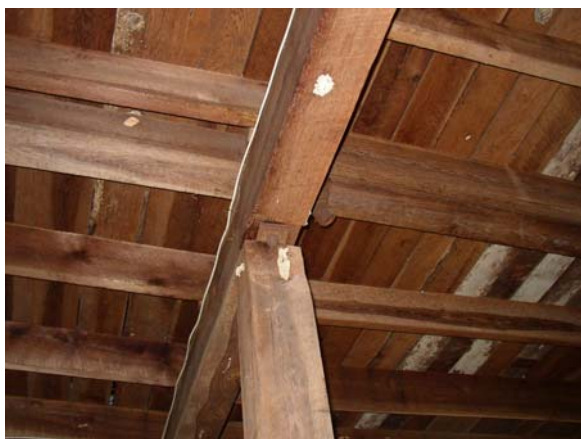
Figure 6 Structural framing.

The maintenance shed has balloon-frame, exterior-bearing walls with interior post girder at the long axis of the structure. The facility remains in good structural condition. Observed conditions include:

- Gabled roof with asphalt shingles and no perimeter gutters
- Wood stairs to hayloft that do not meet code
- Painted exposed rafters at roof eaves; no cornice system
- Southern pine wood lap siding in fair to good condition
- Concrete slab-on-grade foundation in good condition
- Original pulley system intact in hayloft
- Two original sliding wood garage doors, painted, with overhead roller mechanisms
- Multi-light single-pane wood windows, painted
- No restroom facilities
- Entrance and egress non-accessible (ADA-ADAAG)
- Hayloft used as storage for Buildings 1556, 1557, and 1558

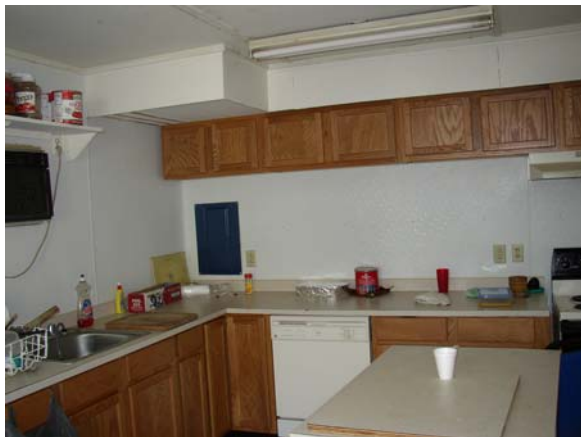
Figure 9 Interior of Building 1553

Building 1553 is in good condition with minor deterioration. Observed conditions include:

- Single-glazed fixed six-light wood window on south façade
- Visible rot deterioration on bottom row of painted horizontal wood lap siding
- Asphalt-shingle gabled roof in good condition
- Painted exposed wood rafters at eaves
- Concrete slab-on-grade foundation in good condition
- Textured marlite panel interior walls in fair condition
- Base and wall cabinets in fair condition

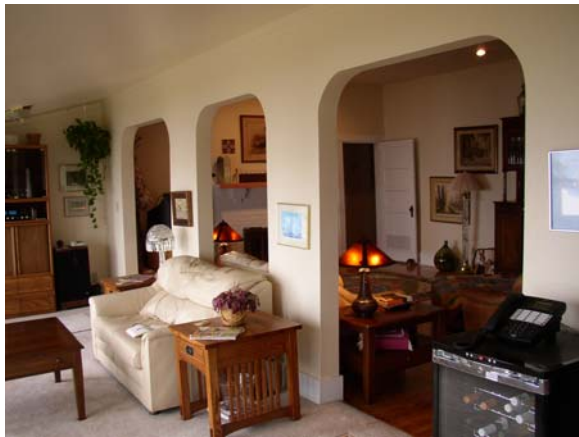
Figure 12 View looking into living room from sunroom.

- Roof structure, insulation, soffit, and fascia are in good condition
- Asphalt-shingle covering is in good condition
- Water stains on sunroom ceiling
- Masonry foundation is in good condition
- Noted animal infestations in the crawl space
- Exterior wood frame walls are in good condition
- Board-and-batten vertical wood siding in fair to good condition
- Single-glazed double-hung wood windows with single-glazed double-hung aluminum storm windows are in fair condition

- Aluminum-frame double-glazed insulated glass windows in sunroom are in fair condition
- Pine tongue-and-groove flooring; floor not level in various locations throughout the house; some missing floor filled in with wood putty
- Ceramic tiles in kitchen not level
- No visible evidence of carpenter ants or termites
- Carpeting in sunroom leans out because room was originally a porch sloping away from the house
- Centralized air conditioning and electric resistant heating system
- Furnaces for heating and cooling date from late 1990s and are in good condition
- Overhead electric service with fully ground panels
- Electric panel is in fair condition

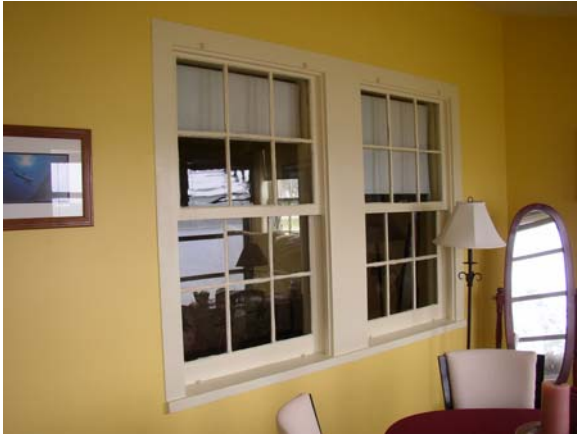
Figure 15 Windows dating to original construction period in sunroom.

- Gas heating system in good condition
- Exterior electric cooling system dates from 1986 and is in poor condition
- Overhead electric service, fully grounded panel and wiring

- Electrical panel and receptacles are in poor condition and approaching or beyond service life
- Interior finishes are in fair condition
- Kitchen includes older cabinets with newer countertops

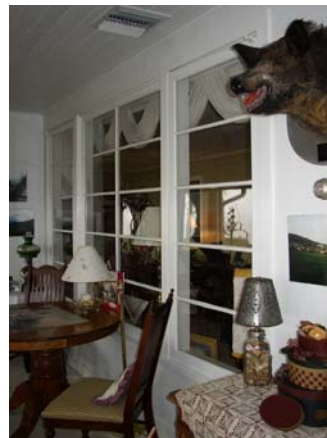
Figure 26 Former exterior windows now located in sunroom.

- Roof structure, insulation, soffit, and fascia are in good condition with some staining and minor deterioration
- Wet roof rafters over sunroom are evident when sunroom ceilings are opened
- Wood-framed and terra cotta block tile exterior walls are in good condition.
- Termites are suspected to be within the walls of the facility; although no one knows for sure because no walls have been opened up recently
- The enclosed porch has vertical wood shiplap siding
- Stucco is the prominent exterior finish and is in good condition
- Masonry foundation is in good condition
- Wood floor joists, although uneven in some areas, are in good condition

- Four-over-one wood windows dating from the 1930s/1940s are leaking and allow air and dirt to blow into the house
- Aluminum replacement windows are fixed
- Wood entry doors are in excellent condition
- Carpenter ants have been problematic in the kitchen
- Kitchen has been updated
- Two gas-fired furnaces from the late 1990s are in good condition
- Cooling coils from the late 1990s are in good condition
- The two electrical panels at the property are in good condition
- Electrical receptacles are in good condition
- Interior finishes are in fair to good condition

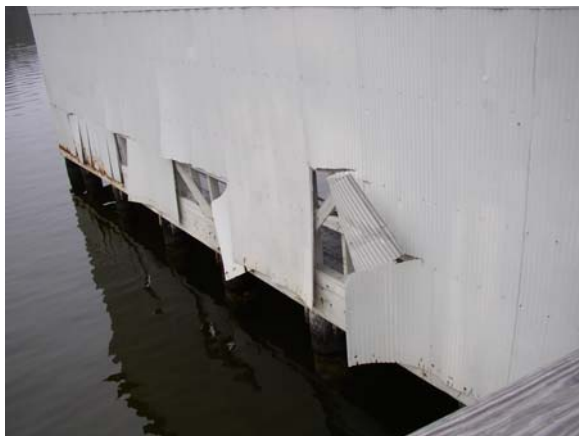
Figure 28 Damaged siding.

- Corrugated metal siding is separated from the structure in some places.
- Boardwalk to boathouse is leaning.

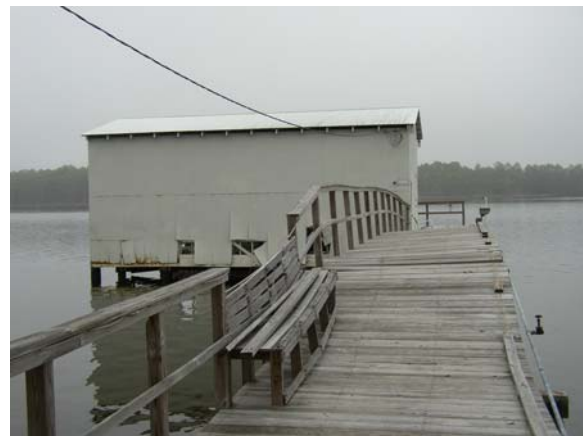
Figure 29 Boardwalk to boathouse.

- Boardwalk lacks support capacity of International Maritime Code (IMC) requirements of 65 lbs/sf live load.
- Railing is below International Building Code (IBC) requirements of 80lbs/sf, horizontal.
